# **Abbreviated Preliminary Assessment for GVD Property (Formerly a Kootenai County Landfill Site)**

**State of Idaho  
Department of Environmental Quality**

**December 2012**

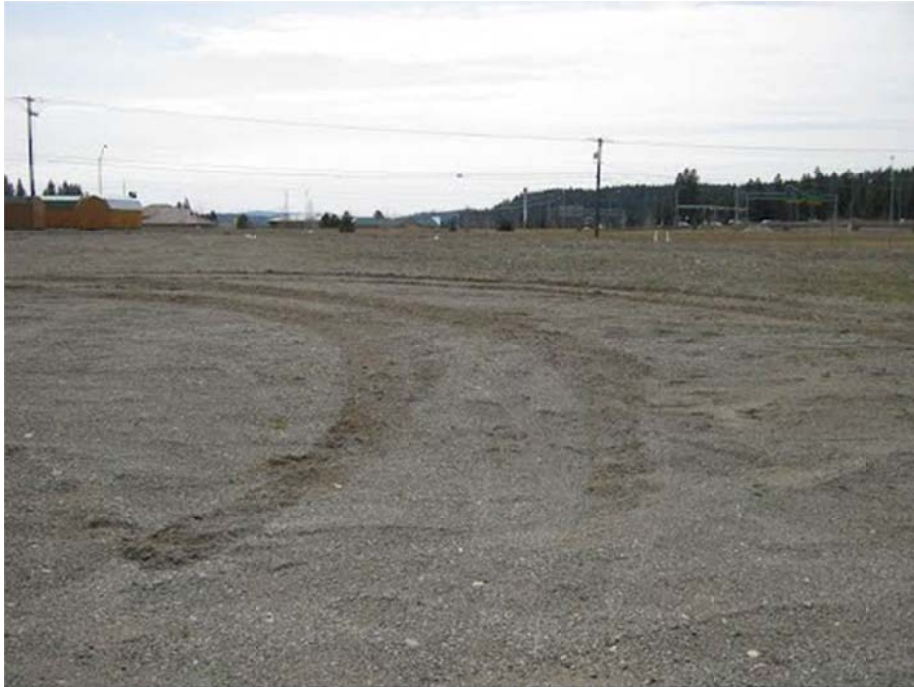
Photo 1 shows the currently vacant GVD property site.

**Photo 1. GVD property viewed from the northwest to southeast.**

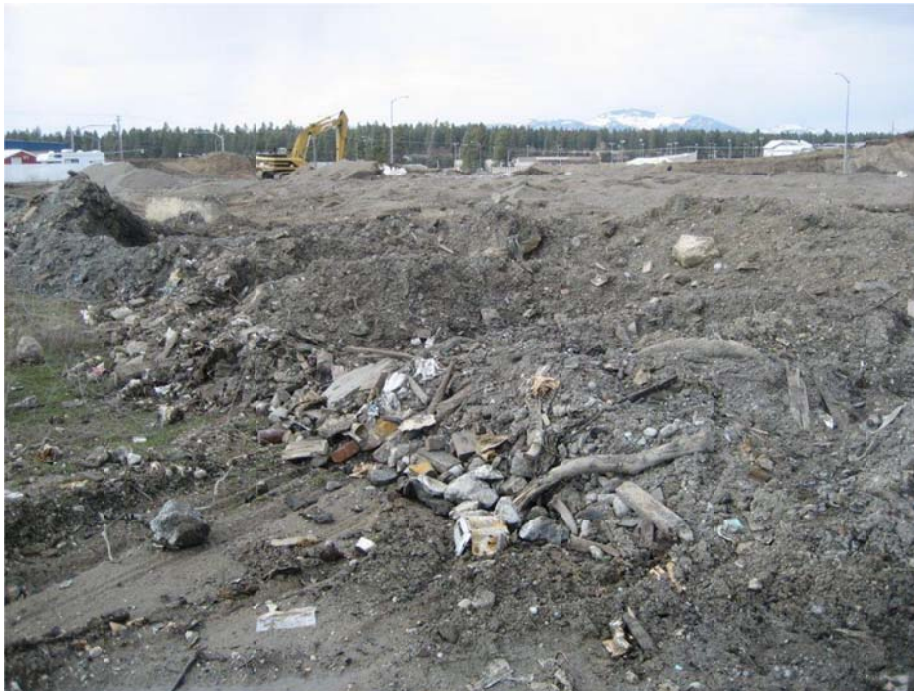
Photo 2 shows the solid waste exposed during a 2009 excavation of the property.

**Photo 2. Solid waste located on the GVD Property following excavations in 2009.**

As a result of DEQ's research and observations, the department recommends that the GVD property be referred to the DEQ solid waste removal program to work with the parties responsible for the landfill to remove the waste. Sections 2 through 5 provide further support for this determination.

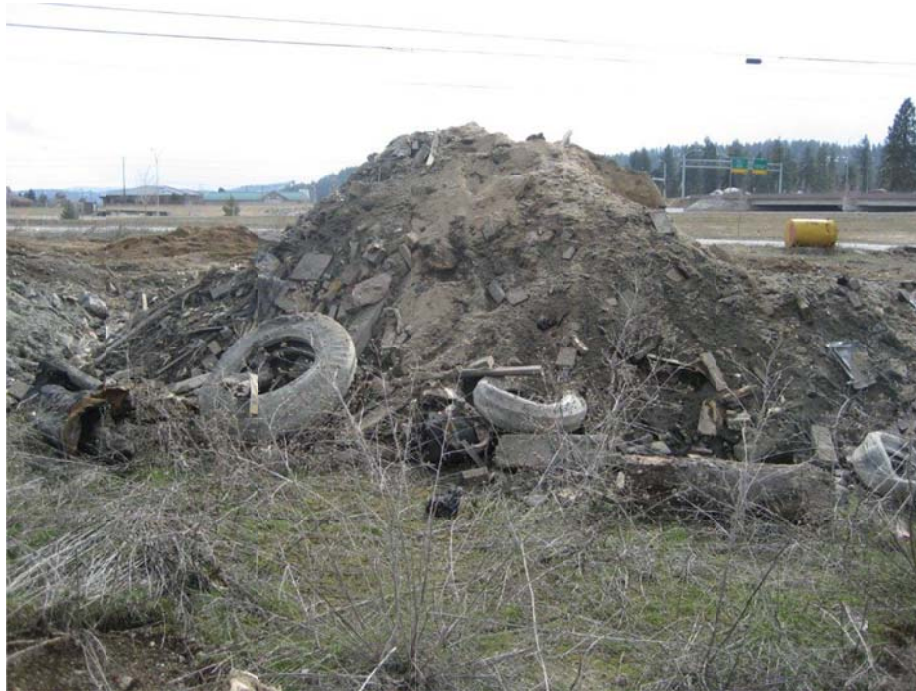
Photo 3 shows typical solid waste excavated on the GVD property in 2009.

**Photo 3. Solid waste excavated on the GVD property in 2009.**

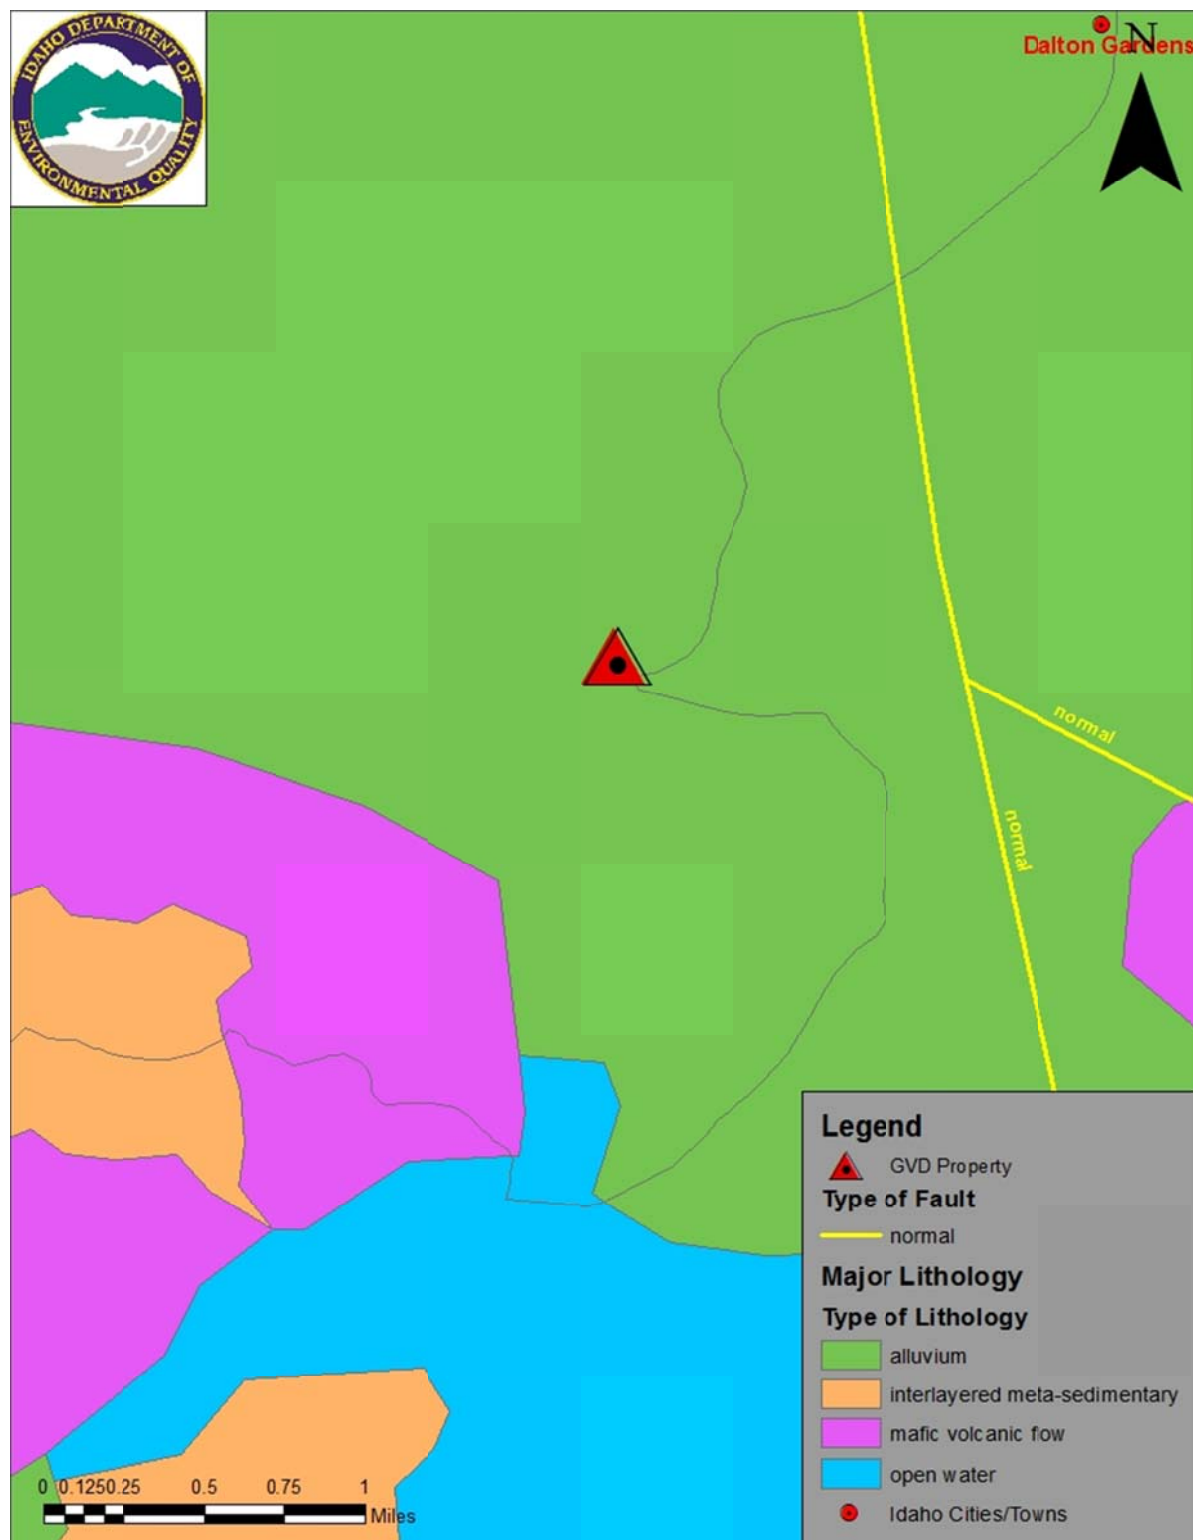
**Figure 3. Map of major lithology in the vicinity of the GVD property.**

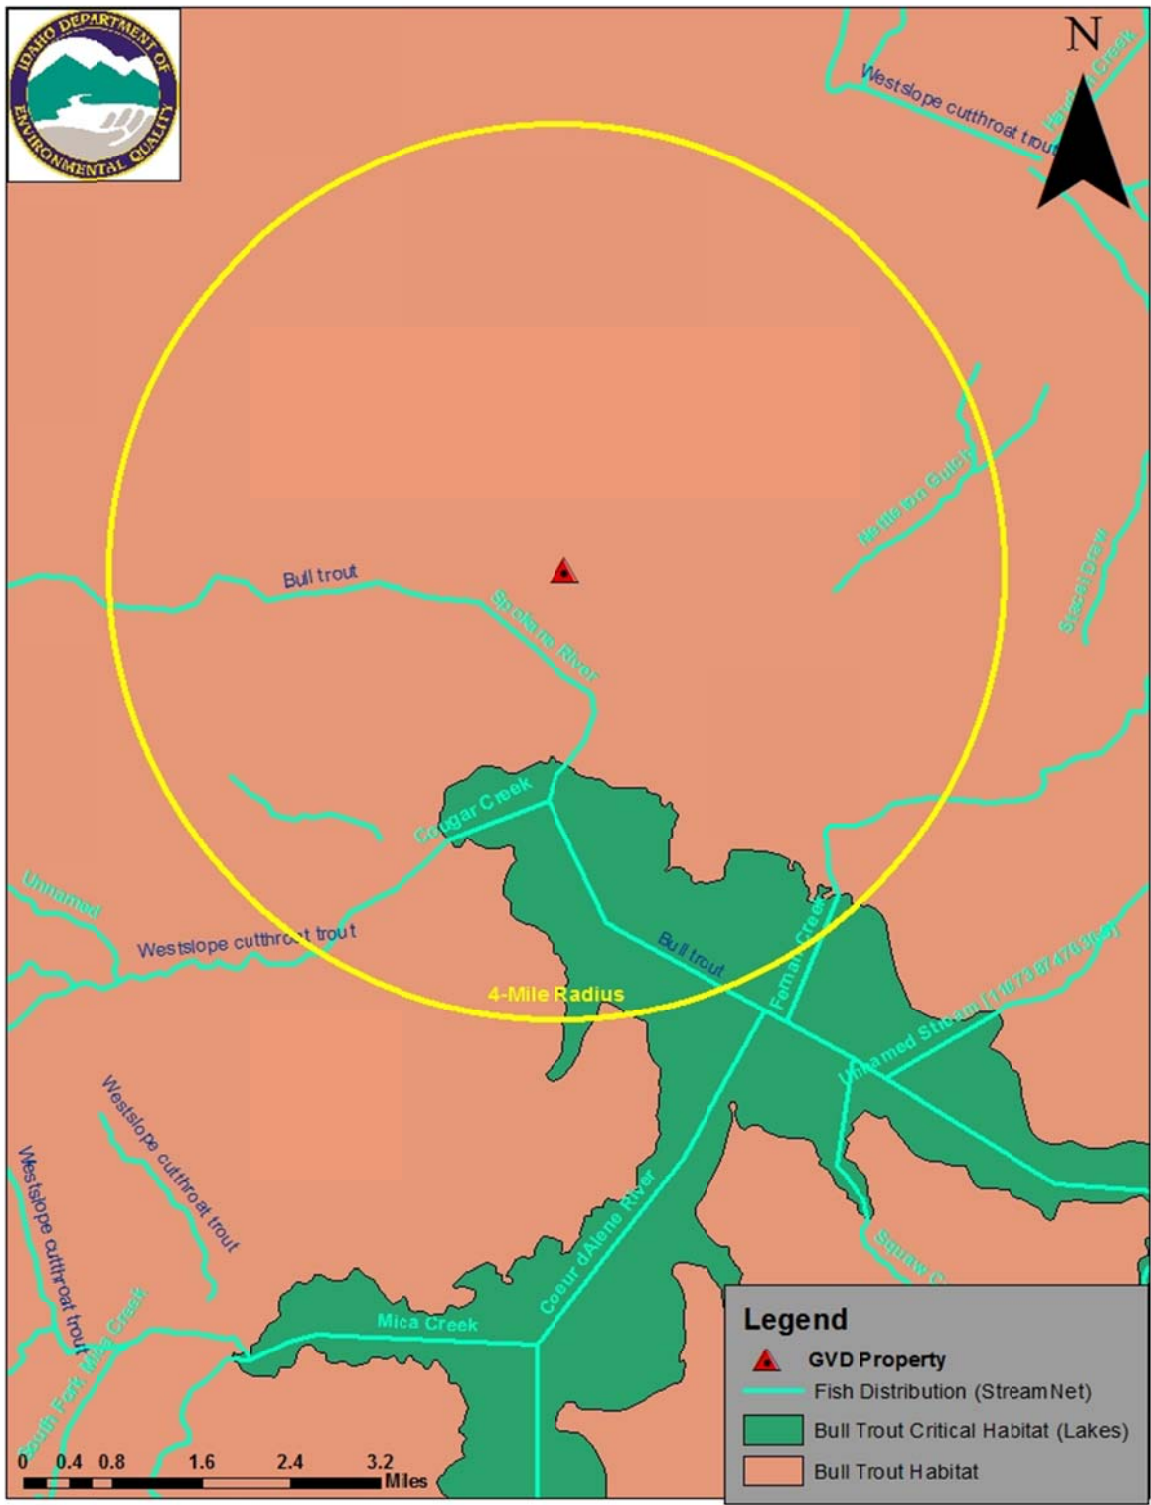
**Figure 7. Fishery sensitive species within 4-mile radius and surrounding area of the GVD property.**  
(Source: SDE Feature Dataset, Animal Conservation Database. Idaho GIS ArcSDE 9.2 Geodatabase)
